馬太鞍溪堰塞湖災後復原情形

堰塞湖目前觀測狀況

農業部林業及自然保育署

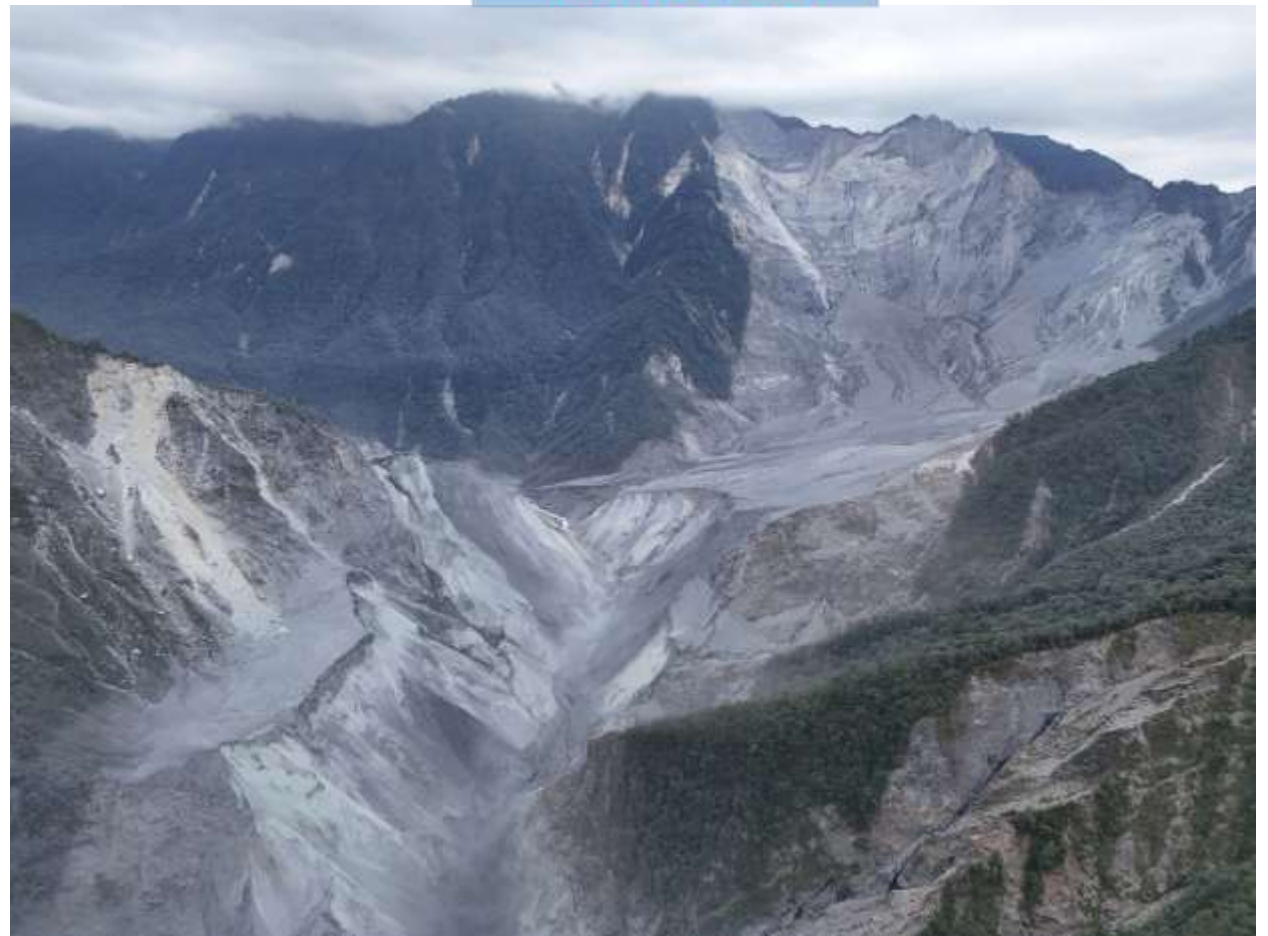
壩體溢流破壞前後比對

- 天然壩坡度變緩(坡度35% →10%)，氣候穩定情況下，潰壩機率降低。
- 依Logistic regression model，潰壩機率亦大幅降為18%。

- 新河道兩側邊坡高陡無耐震力、暴雨或地震後崩滑機率高。
- 未來可能再次阻塞溢流口，蓄水量視阻塞量體而定。

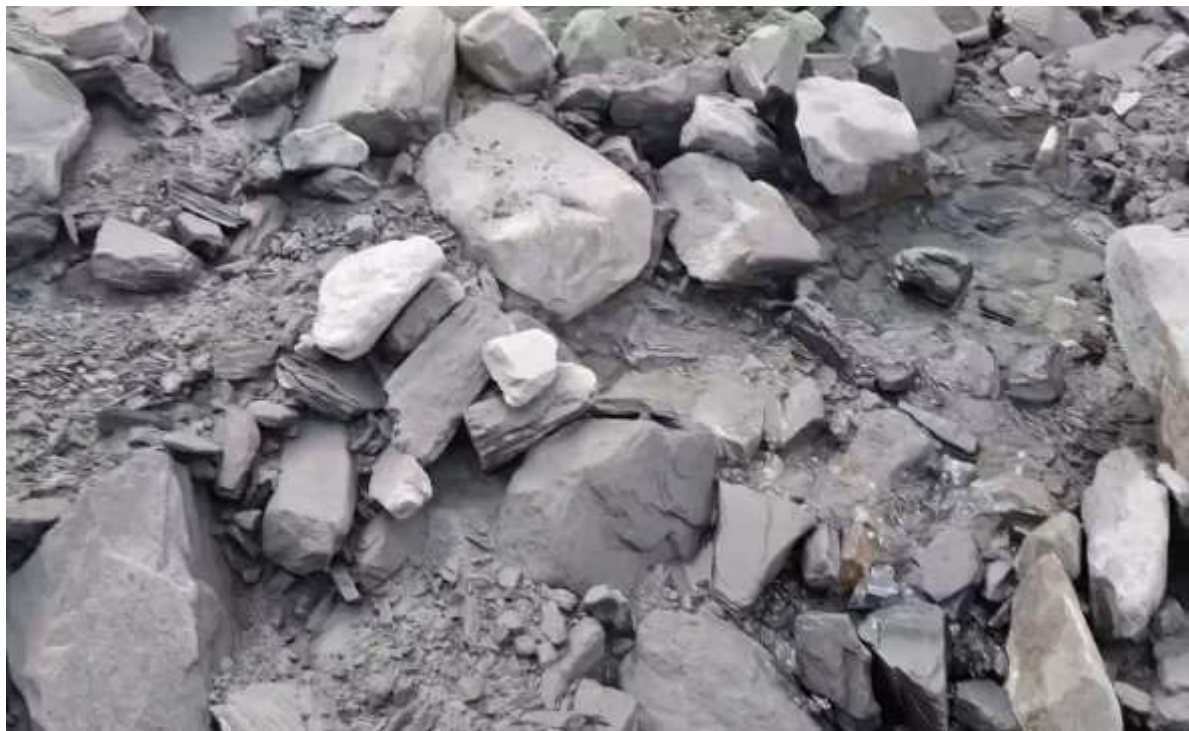
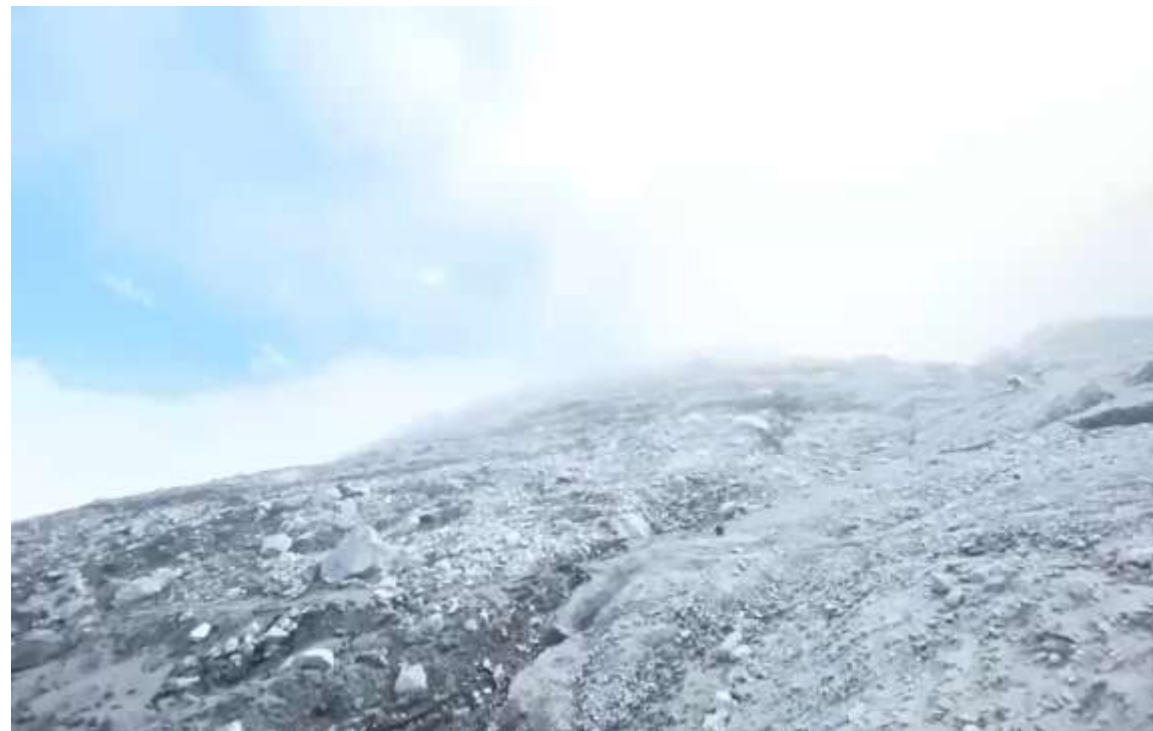
- 沿途多處坍方、崩塌與厚層泥流堆積，**地勢陡峭、土質鬆軟且地面濕滑**。
- 湖區附近地表及植物樹葉上均**覆蓋厚重的粉塵、泥砂**，呈現灰白荒蕪景象。

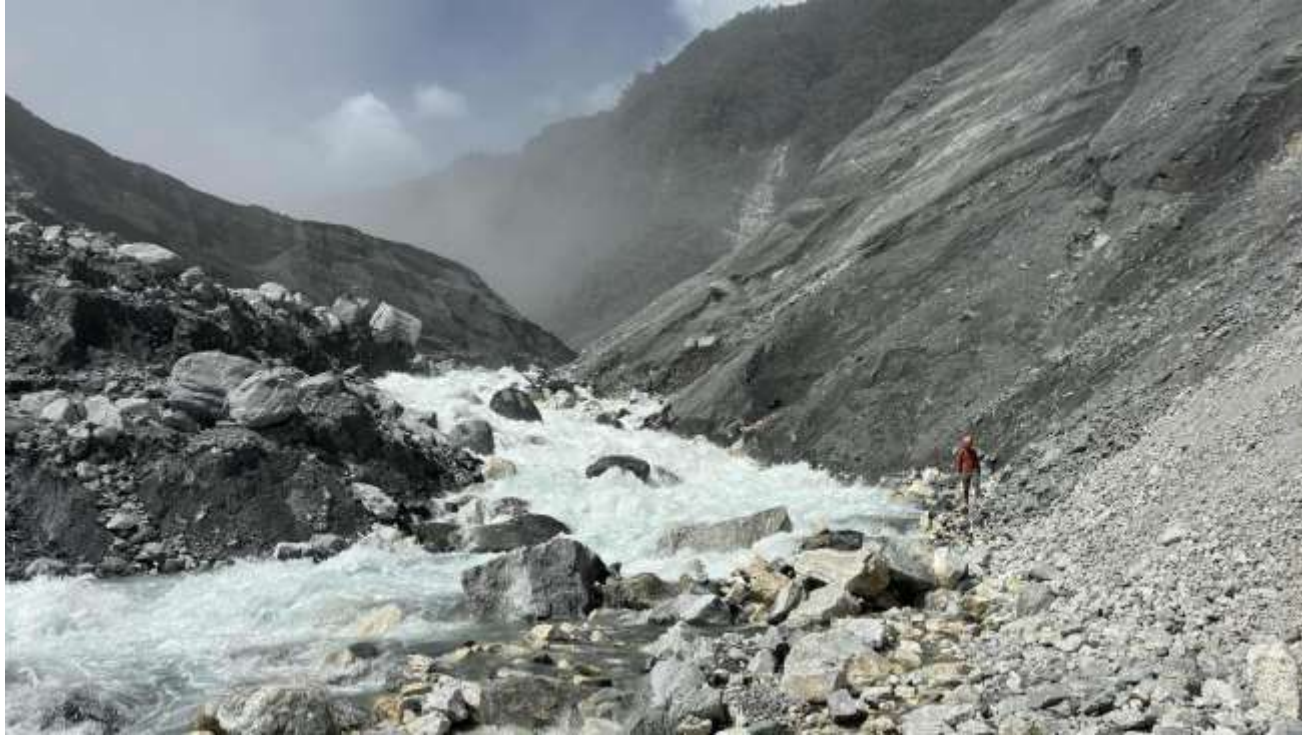
- **湖水持續溢流，壩體邊坡仍不穩定**，兩側邊坡暴雨崩滑機率高。

- **強化監測及警戒：**以衛星影像、航拍攝影、無人機空拍、網路監視器即時影像、下游水位計與即時影像等多元管道，密切監控堰塞湖與下游河道水位，依據警戒機制及時發布災害預警。
- **開設溪床便道：**10月4日已先擇定馬太鞍溪北岸緩坡處做為汛期後嘗試開設溪床便道之起點。若能於非汛期開設至壩體下方，將評估可否針對壩體進行降挖與穩定工程。
- **河道土砂清疏及防砂工程：**辦理國有林範圍土砂清疏，以增加河道洪水容受力；設置防砂設施以穩定流心，調節及控制土砂下移。
